The Artifacts in MRI

新光吳火獅紀念醫院 放射診斷科
技術專員 李正輝

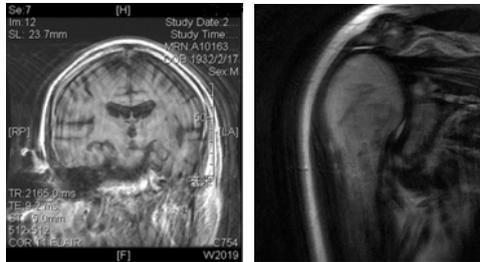
• Patient motion

- *Solution of patient motion*
 - fixed patient, repeat scan, reduce scan time, drug-assisted
- *Solution of physiological motion*
 - hold on breath, respiration gating, respiratory compensation, ECG gating, fast scan technology, drug-assisted

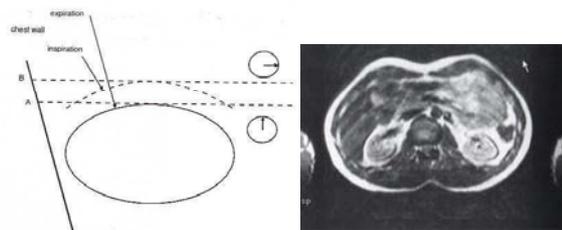
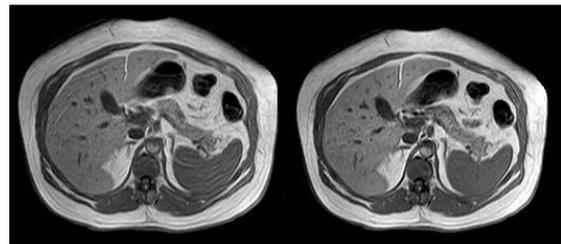
Motion Artifact(Respiratory)

Respiration

Breath-hold

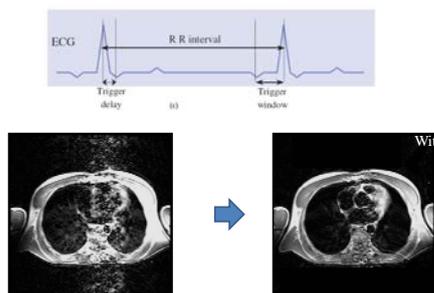
ECG Gating

- *Involuntary motion*
- *ECG trigger or PPU trigger are used to avoid artifacts*
- *MR compatible electrodes use carbon instead of metal to avoid causing artefact on the MR images*
- *Scan time is determined by the heart rate*
- *The TR is controlled by the R-R interval*

- *ECG gating is a more accurate gating method*
 - *peak is usually sharp and easily recognizable*
 - *all the other ECG peaks can be seen too*
 - *good for cardiac imaging*
- *Peripheral gating only detects the arterial*
- *Pulse peak is much broader wave*
- *Ease of preparing the patient*

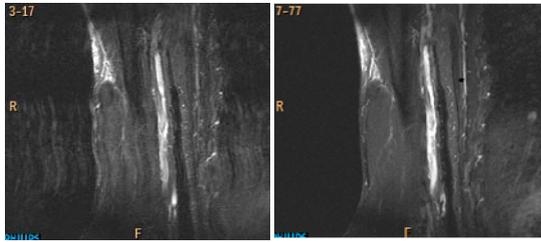
- *Spatial saturation bands*, also known as *REST slabs* or *pre-sat bands*, are simply slice selections, and can be used in many ways

Two MRI scans showing spatial saturation bands. The left scan (a) shows a sagittal view with a saturation band, and the right scan (b) shows an axial view with a saturation band.

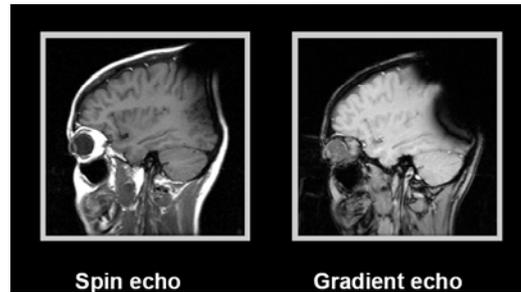
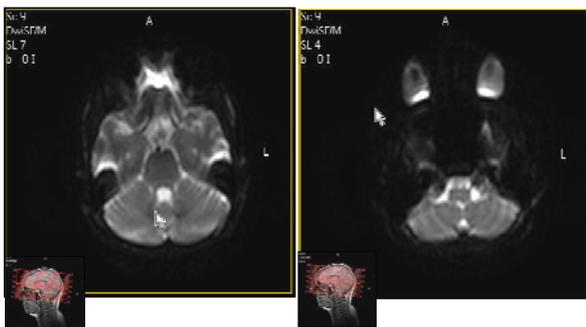
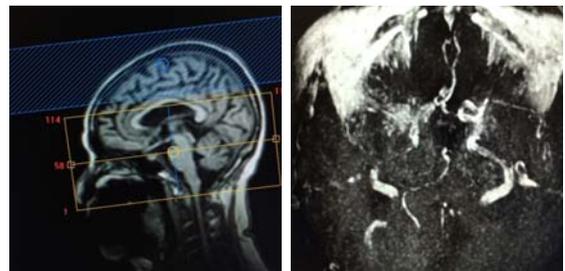
Mental Artifacts

- Metals caused homogeneity change

- Susceptibility artifacts in MRI occur at *interfaces of differing magnetic susceptibilities*, such as at tissue-air and tissue-fat interfaces (examples include paranasal sinuses, skull base, and sella)
- There are caused by *inhomogeneities*, susceptibility artifacts are generally worse on *gradient-echo* images than *spin-echo* images.

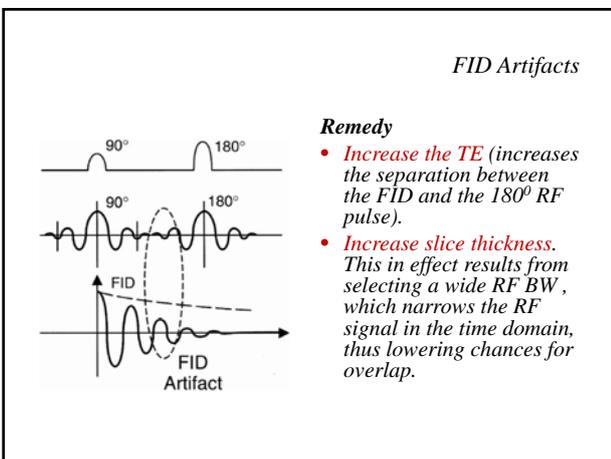
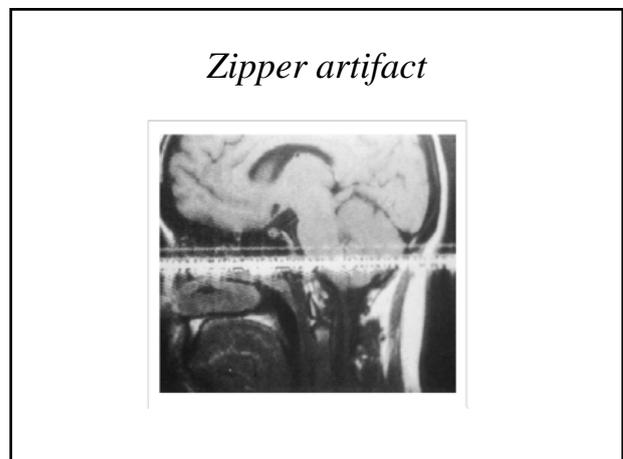
FID Artifacts

- Free induction decay (FID) artifacts occur due to overlapping of side lobes of the **180° pulse** with the **FID** before it has had a chance to completely decay. This overlapping causes a “zipper” artifact
- **Along the frequency -encode direction.**

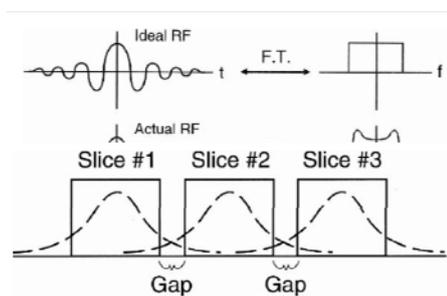
Cross-talk

- At least a **30% gap** between the slices.
- Excite alternate slices (**interleaved**) during the acquisition.

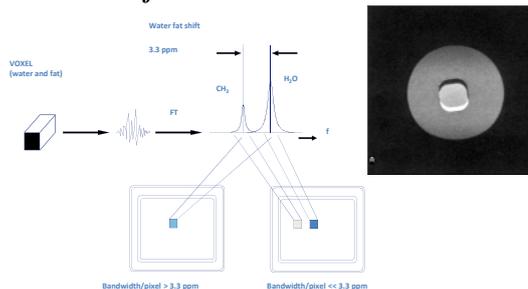
Chemical shift

- Caused by the different chemical environment of fat and water.
- The precessional frequency of fat < water (depend on the main magnetic field strength)
ex. At 1.5T the different of precessional frequency is 220 Hz; at 1.0T is 147 Hz. But at lower field strength (0.5T or less), it is usually insignificant.

- For example :
The frequency mapped across the FOV is 32000 Hz; 256 frequency samples are selected, each pixel has an individual frequency range of 125Hz (32000/256Hz). At 1.5T, fat and water existing adjacent has a shift about 1.76 pixel which called chemical shift

- It depend on the **size of FOV** as this determines the size of each **pixel**.
- Causes a **dark edge** at the interface between fat and water.
- It occurs along the **frequency encoding axis** only.

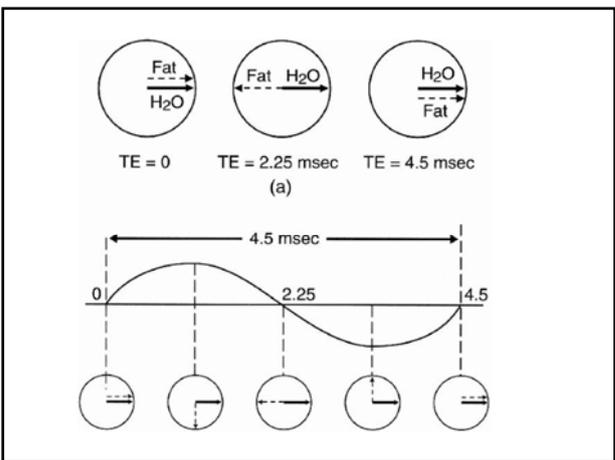
- Also produced as a result of the precessional *frequency different between fat and water*.
- Caused because fat and water are in phase at certain times and out of phase at others.

- When fat & water are in phase:
 - ➔ signals add constructively.
- When fat & water are out phase:
 - ➔ signals cancel each other out.

- Cause a ring of dark signal around certain organs where fat and water interfaces occur within the same voxel.

- Use a *spin echo sequence* to reduce the artifact.
- Select a *TE* generates an echo when fat and water are in phase. (at 1.5T the TE is a multiple of 4.2ms)

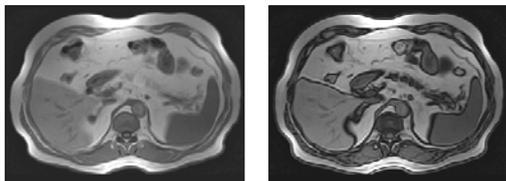
Chemical shift for in-out phase

FIELD STRENGTH	In	Out	In	Out	In	Out	In
0.5 T	0	6.8 ms	13.6 ms	20.4 ms	27.2 ms	34 ms	40.8 ms
1.0 T	0	3.4 ms	6.8 ms	10.2 ms	13.6 ms	17 ms	20.4 ms
1.5 T	0	2.2 ms	4.4 ms	6.8 ms	9 ms	11.2 ms	13.4 ms
3.0 T	0	1.1 ms	2.2 ms	3.4 ms	4.5 ms	5.6 ms	6.7 ms

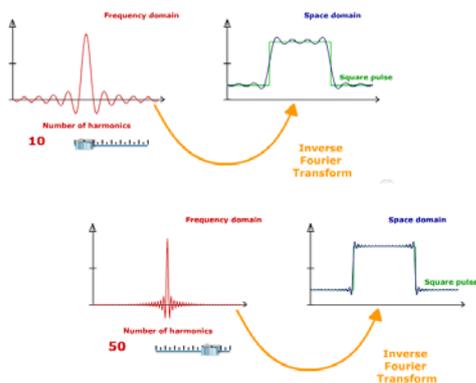
- Caused by **under sampling** of data so that interfaces of **high and low signal** are incorrectly represented on the image.
- Occurs in **the phase direction** only.
- Produces a low intensity band running through a high intensity area.

- Also called:
 - Gibbs artefact
 - Ringing
 - Spectral leakage
- Predominant in case of
 - low matrix
 - scan percentage $\ll 100\%$

- Increase sampling time (BW)
- Decrease pixel size:
 - The under sampling of data must be avoided.
 - ➡ increase the number of phase encoding steps.
- Decreasing the FOV

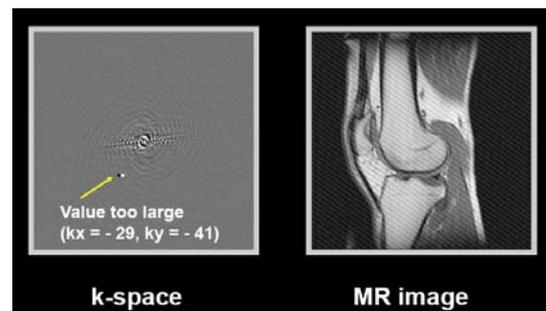
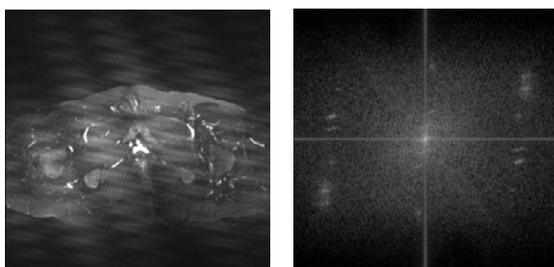
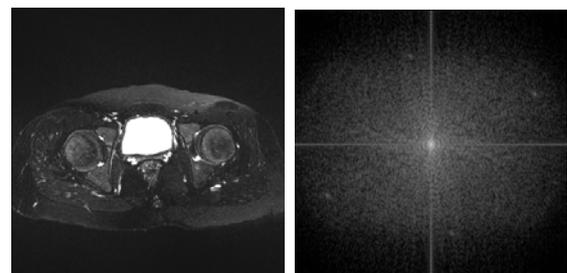
Herring-bone artifact

- A regular series of *high- and low-intensity stripes* extending right across the image
- It is caused by *spike noise* in the raw data, whose Fourier transform is then convolved with *all the image* information

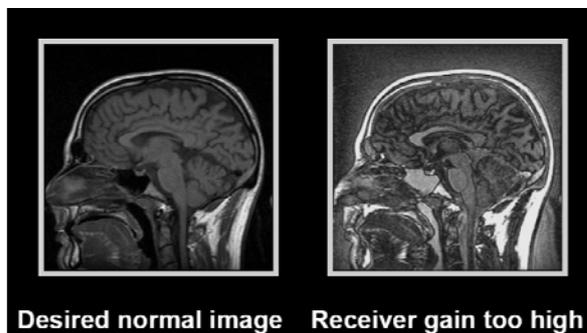
Halo artifact

- A halo effect can be produced if *the receiver gains are incorrectly set*.
- When this happens the *signal is too large for the range of the digitizer and information in the center of k-space is lost*
- It is a rare artifact with modern *automatic pre-scan systems*, and is more likely to occur when receiver gains are manually set
